Manhole Inspection Summary

Manhole # S19KK_032MH

Location Address: **2123 CLIFTON-RIDGEHILL**

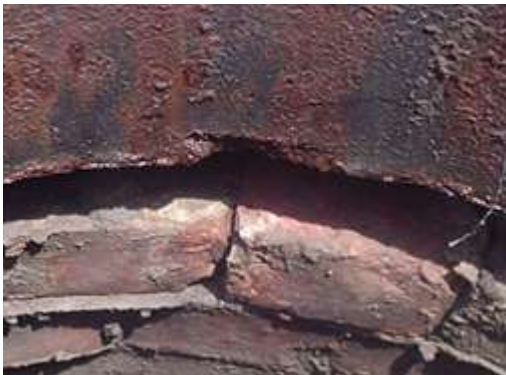
Condition: ☐ Sound ☒ **Cracked** ☐ Leaks

little bit of a broken frame

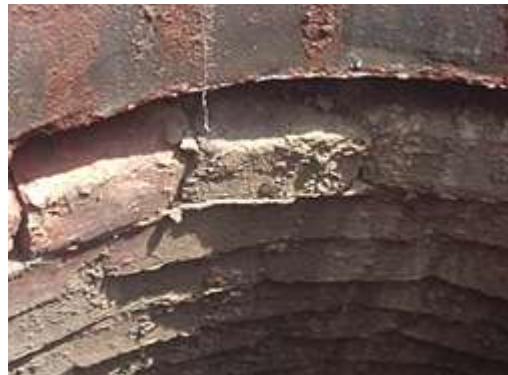
Defect 2

Condition: ☐ Sound ☐ Cracked ☐ Root Intrusion ☐ Loose Brick ☒ **Deteriorated**

DETERIORATION OF CHIMNEY

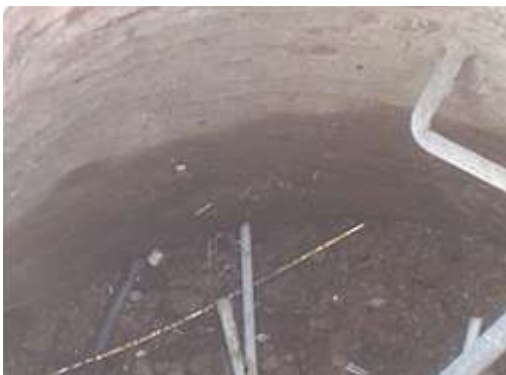
Defect 1

Infiltration: ☐ None ☒ **Joint** ☐ Cracks ☐ Mortar ☐ Roots ☐ Wall

Condition: ☐ Sound ☐ Cracked ☐ Root Intrusion ☐ Deteriorated ☐ Leaks ☒ **Debris**

INFILTRATION OF BARREL JOINT,
DEBRIS IN CHANNEL

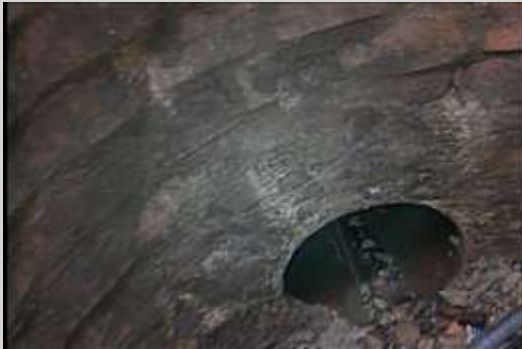
12 O'Clock Outflow

Deposits: ☐ None ☐ Mud ☐ Sludge ☒ **Debris** ☐ Grease

Silt Depth: **1** (in.) Deposits Extent: **Light**
